Report No. 4914-801

INVESTIGATION INTO DEEP-DRAFT VESSEL

BERTHING PROBLEMS AT SELECTED U.S.

**NAVAL FACILITIES**

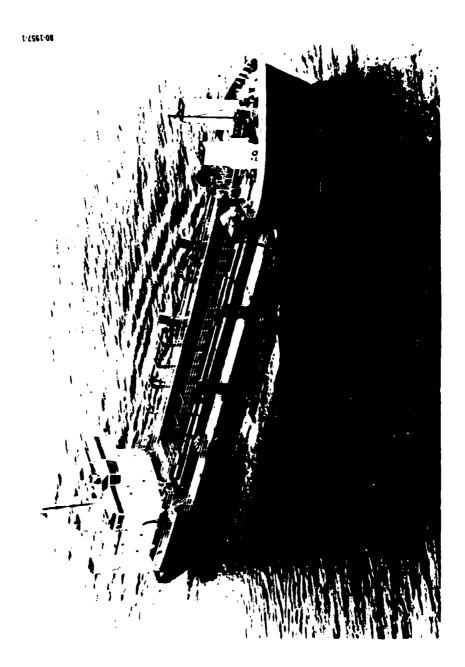
2.4.1 <u>HOPPER DREDGE</u>. A hopper dredge, which is shown in Figure 2-1, basically consists of a hugh holding tank(s) or hopper surrounded by a ship. The tank is filled in the following fashion. A dredging head, located outboard of the ship and at the lower end of a pipe connected to a centrifugal pump ploughs along the bottom

loosening the sediment. The hopper dredge moves forward at a speed of about three knots. The head weighs on the order of 10 tons. Simultaneously, the centrifugal pump pumps the loosened sediment into the hopper. When the hopper is filled the dredge steams to a disposal area, the bottom doors open and the dredge spoil contained in the hopper is released.

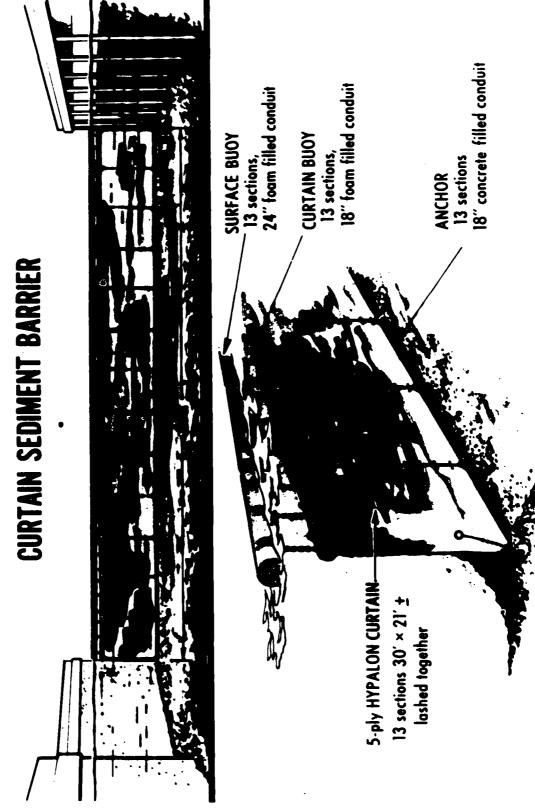
Figure 2-2. Curtain Sediment Barrier

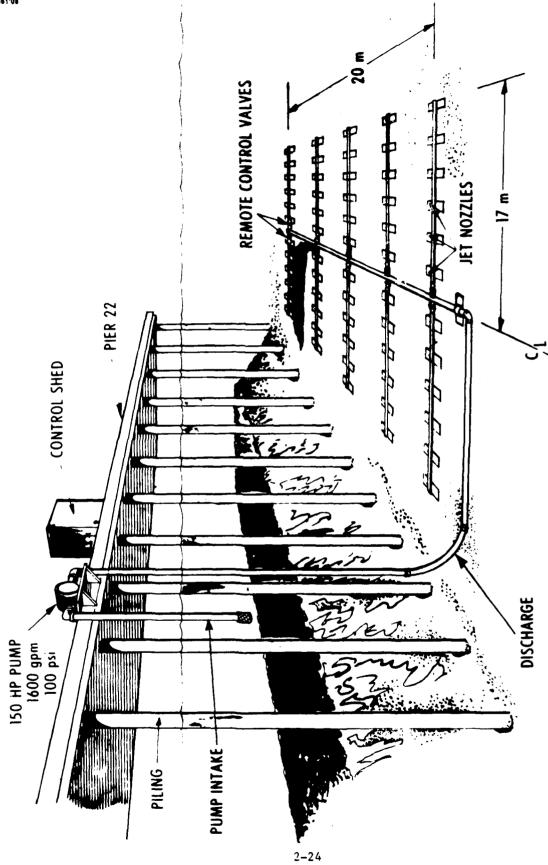
Presently installed at Pier 235 Mare Island Ship Yard, San Francisco, CA, is such a system (Van Dorn, et al, 1978). Shown in Figure 2-3 is a ten-branch, 150-hp, 1,000 square meter array of 60 hydraulic jets designed, fabricated, and emplaced on the predredged mud bottom of a capital ship berth at Mare Island Naval Shipyard. Actuated twice daily for 35 minutes in synchronization with the ebb flow in Mare Island Strait, the array controlled sediment deposition within the perimeter of influence. A control area in an adjacent berth having a similar size and exposure experienced a 45 cm (18 in.) deposit in an abnormally dry year 1977. An equivalent area in the same berth, but behind the array, received about half the latter deposit as the result of partial shielding by the array.

Figure 2-3. Prototype 60-jet Array Installed at Mare Island Shipyard

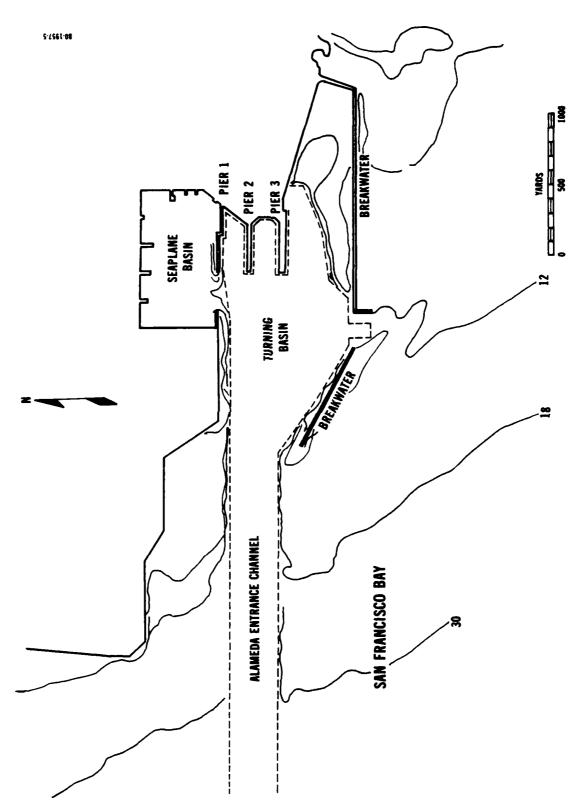
Figure 3-2. Details of the Berthing and Turning Basin Facilities of the Alameda Naval Air Station

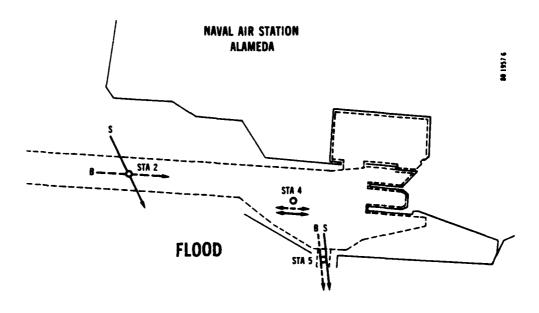
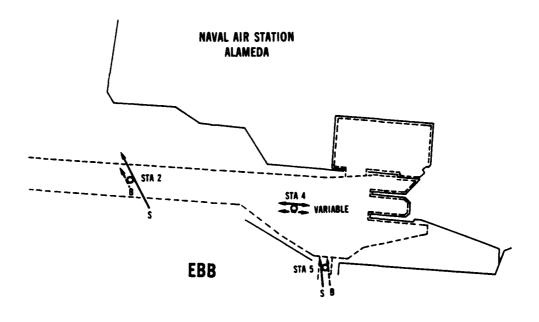
Figure 3-3 shows surface and bottom current directions during flood and ebb tides near the channel entrance, in the turning basin, and just outside of the 750-foot gap in the breakwater at Alameda Naval Air Station. There is a remarkable difference between the direction of the flood currents in the upper and lower water column. The flow in the upper column crosses the channel in a southeast direction, while at the same time flow in the lower strata makes a sharp turn into and moves eastward up the channel. Thus, the tidal prism within the basin fills largely through the lower water column. Surface and bottom ebb currents in and near the channel entrance move in approximately the same direction as the flood currents. The tidal prism empties largely through the upper water column, the surface ebb currents ranging up to a maximum of 2.5 feet per second, while the bottom currents range from 0 to 0.2 feet per second during the entire phase of the tidal cycle. The velocity of circulation in the turning basin and the berthing area is very weak since the surface and bottom currents are near slack most of the tidal cycle. Peak velocities on the bottom are about 0.3 feet per second and at the surface range up to 0.5 or 0.6 feet per second for only a few hours during the tidal cycle. Surface and bottom flood and ebb velocities have maximum values of about 2 feet per second at the 750-foot gap in the breakwater. These are considerably less during most of the tidal cycle. The flow through the gap contributes to what little circulation exists in the turning basin and berthing area, but apparently its influence is not very strong because of the low velocities in the basin.

Figure 3-3. Current Directions in the Approach Channel and Turning Basin of Alameda Naval Air Station

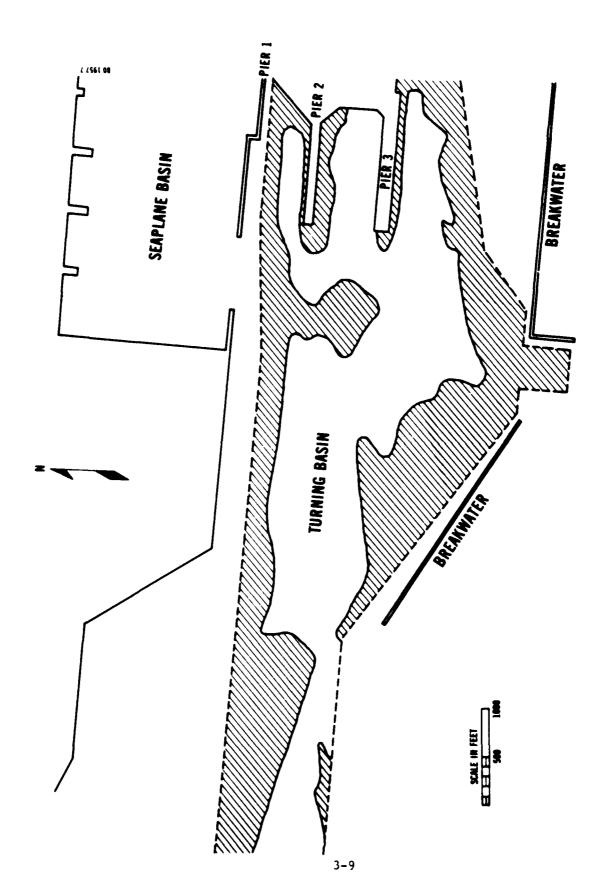
It would appear that muds are migrating on outgoing tides from the shallow seaplane basin into the main turning basin through the 650-foot opening. There is a depth differential of about 25 feet between the seaplane basin and turning basin. A tongue of sediment extends outward some 1,000 feet into the turning basin from the entrance to the seaplane basin, and is quite evident in the dredging sketch.

The sketch also indicates that siltation is probably caused within the turning basin by ebb tides pulling sediment in from the shallow bay area to the south, through the 750-foot wide opening in the southern breakwater. Water depths to the south of the opening are less than 15-feet, presenting an extensive shallow water area that is often high in suspended sediments from wind and wave agitation of the mud bottom.

Figure 3-4. Siltation Patterns in the Waterway at Alameda Naval Air Station

On the north side of the entrance channel and turning basin is a band of siltation running the length of the facility from the east end of the seaplane basin westward to about that point at which the entrance channel intersects the eighteen-foot Bay depth contour. This siltation is probably due to the movement of sediments from the shallow waters immediately to the north of the basin and channel into the deeper water. The incoming tide may accelerate this action as do the effects of propeller wash from ships using the channel. Prevailing north-westerly winds would also enhance the movement of Bay muds into the entrance channel from the north, particularly in that area of open shallow water adjacent to the channel bounded on the north and east by the landing field at Alameda Naval Air Station.

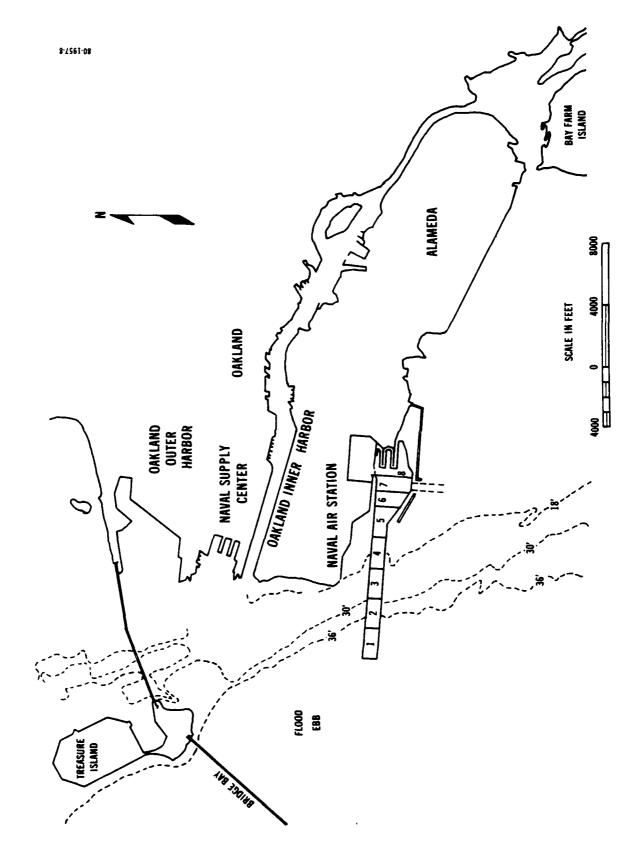
Figure 3-5. Sections of Alameda Waterway for which Shoaling Rates are Tabulated in Table 3-1

TABLE 3-1. ESTIMATED ANNUAL SHOALING RATES IN THE CHANNEL AND TURNING BASIN AT ALAMEDA NAVAL AIR STATION

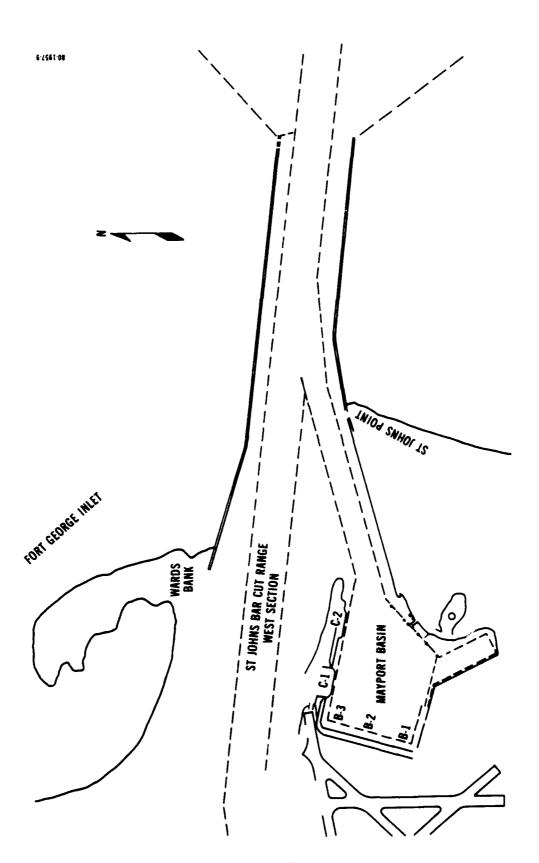
Figure 4-1. Mayport Channel Approach and Turning Basin

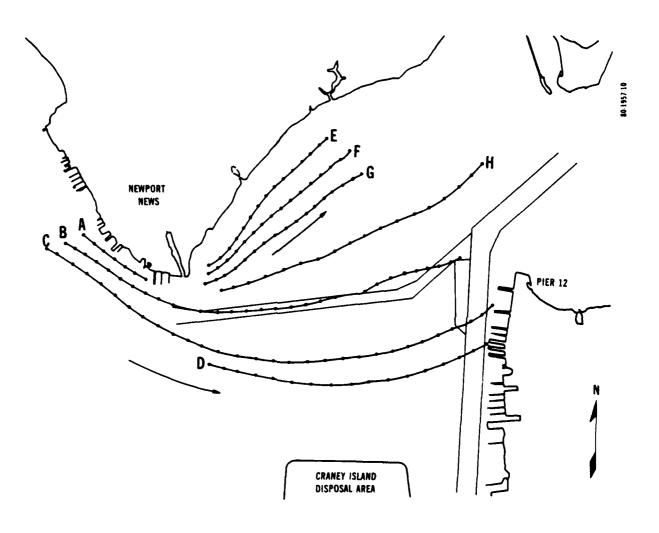
A short-term study for Scripps Oceanographic Institution (Van Dorn, et al, 1977) cites a study by the Virginia Institute of Marine Sciences (VIMS) (Rulecki and Ayers, 1974). Currents measured on 23 June and 15 September 1973 deep within the berthing area on the north side of Pier 12 indicated that both the bottom and surface currents were "weak and erratic rarely exceeding 10 cm/sec (0.2 knots)."

DOTS ON LINES REPRESENT 10-MINUTE INTERVALS. TRUCKS A-D AND E-H WERE OBTAINED ON SEPARATE RUNS.

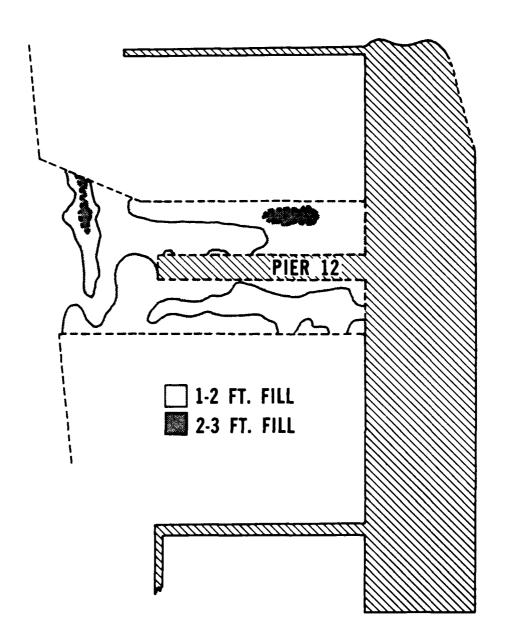
Figure 5-3. Distribution of Siltation Rates in Pier 12 Basins During an 18-month Period, 1961-1963 (after Brehmer, et al, 1967)

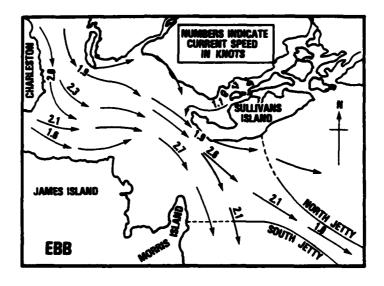
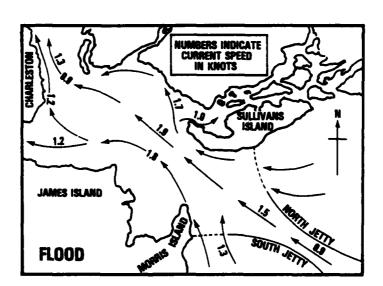
Figure 8-2. Average Surface Current Velocities Due to Tides, Charleston, SC Harbor (Fleet Guide, 1979)

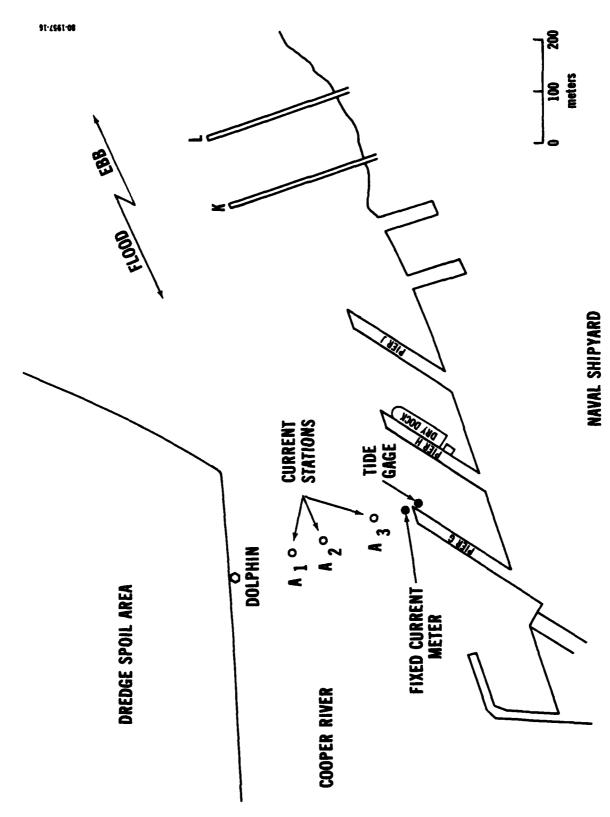
At another location, based on 95 current observations on 15 May 1975 made in the Cooper River during a spring tide range of 6.5 ft, the maximum ebb surface velocity in mid-channel was 1.33 m/sec (4.4 ft/sec or 2.6 knots) (Van Dorn et al, 1977). The location of these measurements is shown in Figure 8-3.

Figure 8-3. Location of Current Measuring Stations at the Naval Shipyard, Charleston, SC

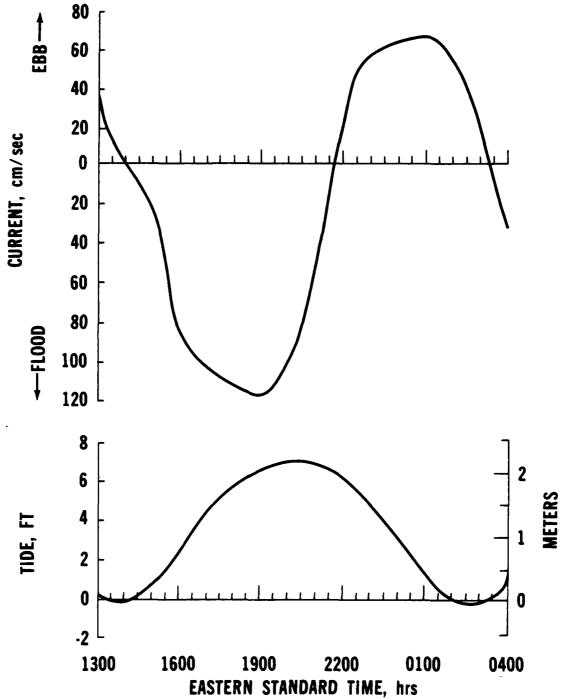
Figure 8-4 shows a 19-hour segment of the record from the fixed current meter that was located 1.5 m above the botton at the end of Pier G, together with the associated tide record. Both ebb and flood currents were very strong, the flood current attaining almost 1.2 m/sec (2.3 knots). Both the duratice and maximum velocity of the flood phase are larger than the ebb, so that the integrated water flux at this depth is upstream. "Since the tidal flux must be equal in both directions, and the entire river has a net positive downstream flux equal to the fresh water runoff from all upstream sources, it is manifest that ebb predominance prevails in the upper layers of the Cooper, and flood predominance near the bottom" (Van Dorn et al, 1977).

NOTE: SENSOR WAS 1.5 METERS (5 FEET) FROM BOTTOM.

Figure 8-4. Tidal Current at the End of Pier G on 15 May 1975

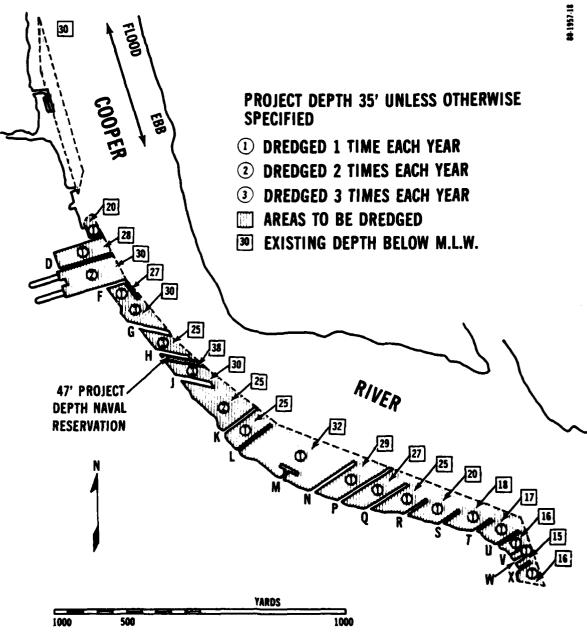
# DREDGED ONCE EVERY THREE YEARS

Figure 8-5. Areas Dredged by the U.S. Navy In and Around Navy Piers and Slips

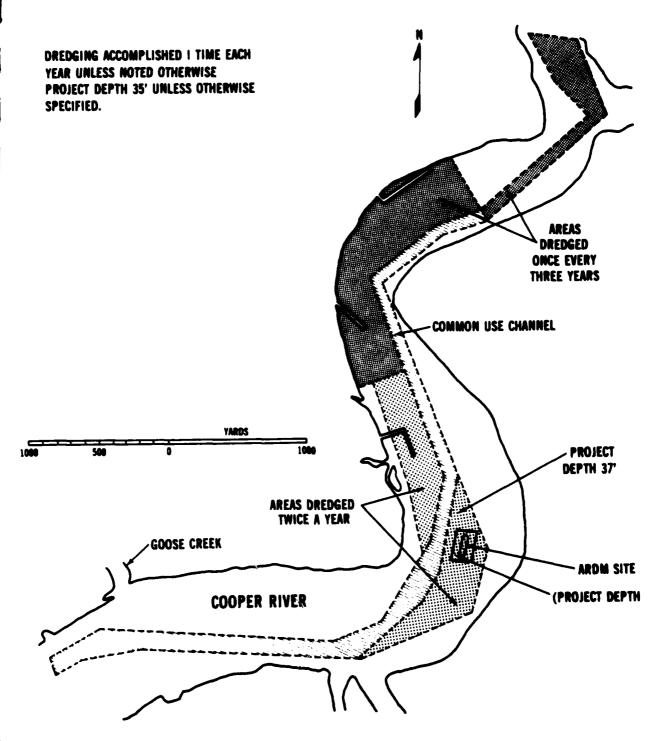
The navigation channel in that portion of the Cooper River abutting the naval facilities is maintained to a depth of 35 feet below Mean Low Water by the Corps of Engineers by means of an hydraulic cutterhead dredge. Detailes concerning the dredging frequency and target depths are shown in Figure 8-6. The dredge spoil, which is pumped to either Clouter Creek disposal area or Yellow Creek disposal area, amounts to about 1,300,000 cubic yards annually.

Figure 8-6. Cooper River Channel in the Proximity of the Naval Facilities Maintained by the U.S. Army Corps of Engineers

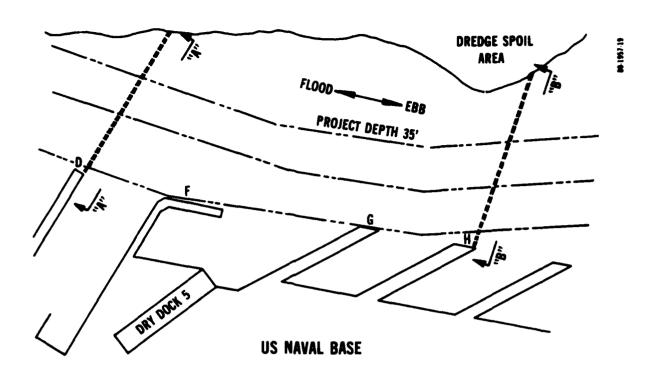
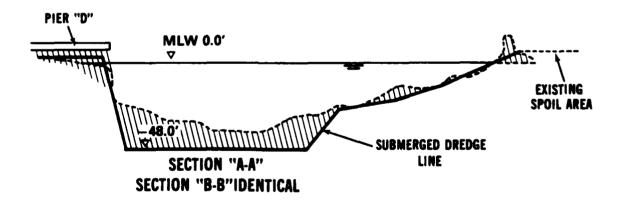
Figure 8-7. Location and Profile of Pipelines for Transferring Dredge Spoil to Clouter Island Disposal Area
